**Flood Control Project Maintenance
Levee Inspections**
LMA District Cover Sheet
Spring 2020 Levee Inspection Results

Madera County FCWCA

Spring 2020 Levee Inspection Results

Waterway			Bank	Unit Miles
Unit No. 01 Ash Slough			Right	2.37
	Spring (March - May)	Summer (June - August)	(September - November) Fall	Winter (December - February)
Unit Maintenance Rating (Fall Only)				
Date of Inspection	4/14/2020 - 4/14/2020			
DWR Inspector	Corey Fujitani			
Accompanied By

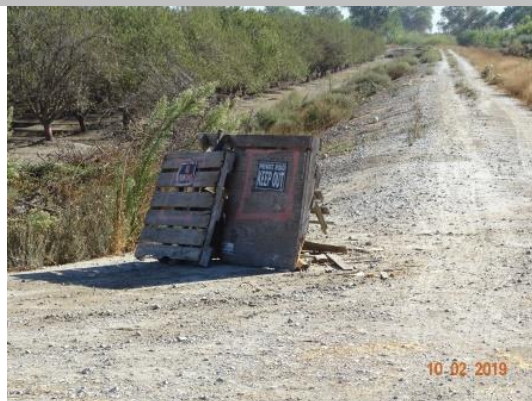
Photo 1 of 2 : SP_2020_NA0011_142_15_20200225_00007.jpg

LM Start	0.02	Rating **	M	Issue No.	15
LM End	0.02	Issue Type +	En	Location *	CR
Category	Earthen Levee			GPS Latitude/Longitude	
				Start	End
Item	Encroachments			37.046524 °	37.046524 °
				-120.427616 °	-120.427616 °
DWR ID	DWR_NA0011_01_f _ 2018_15				
Comment Code					
DE : Debris					
Inspector Comment					
Pallets left on levee crown should be removed.

Pallets used as a sign on levee crown. (Fall 2019)

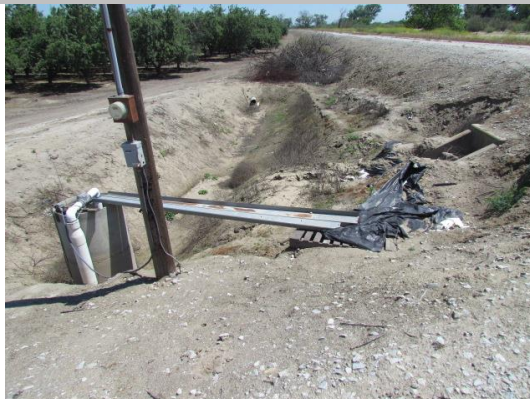
Photo 2 of 2 : SP_2020_NA0011_142_18_20200225_00009.jpg

LM Start	0.03	Rating **	U	Issue No.	18 (cont)
LM End	0.06	Issue Type +	En	Location *	LS
Category	Earthen Levee			GPS Latitude/Longitude	
				Start	End
Item	Encroachments			37.046566 °	37.046715 °
				-120.427512 °	-120.426964 °
DWR ID	DWR_NA0011_01_s_2014_18

Ash Slough looking upstream from the landside slope levee mile 0.03.

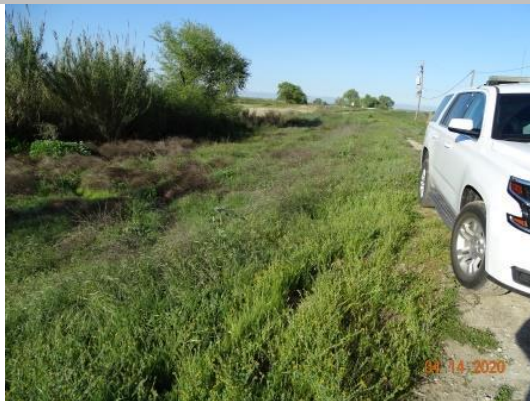
Photo 1 of 1 : SP_2020_NA0011_142_7_20200417_00035.jpg

LM Start	0.03	Rating **	U	Issue No.	7
LM End	0.90	Issue Type +	Ma	Location *	WS
Category	Earthen Levee			GPS Latitude/Longitude	
				Start	End
Item	Vegetation			37.046600 °	37.054865 °
				-120.427453 °	-120.416844 °
DWR ID	DWR_NA0011_01_s_2020_7				
Comment Code					
V1 : Control annual grass and weeds on the levee slopes and easements.					
Inspector Comment

View of vegetation on the waterside slope looking downstream. (Spring 2020)

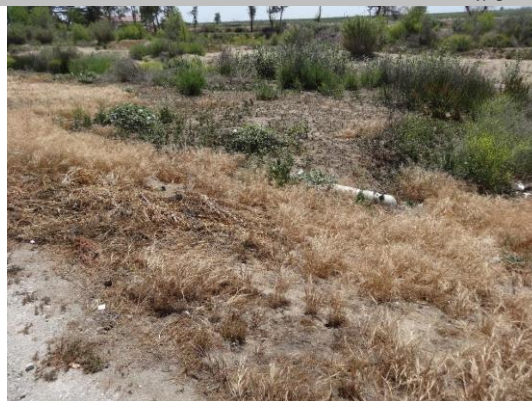
Photo 1 of 3 : UCIP_SP_2020_53153_69674.jpg

DS_ID:21513
FS_ID:53153
EP_NO: N/A
Repair Type: Urgent
Crossing Status: Found
UCIP Comments: 10/31/2018 Erosion present on both the right and the left side of the concrete headwall located on the LS. Pipe inlet is about 50 percent filled with soil. WS outlet is at a low point, water will pond against the levee until it reaches channel elevation. This crossing does not properly drain to the channel. Levee is composed of highly erodible material. Recommend clearing soil from pipe and completing internal pipe inspection to determine pipe integrity through levee. (O. Magana - DWR UCIP)
07/14/2016 No inspection completed--need to inspect October 2016. (DWR UCIP - omagana)05/06/2014 Landward slope has been excavated and a berm built in front of landward headwall. Sediment visible inside pipe from landward side. Dense vegetation limits the inspector's visibility to identify signs of pipe failure (leaks) along the waterward slope. Recommend removing vegetation along pipe alignment and waterward headwall to conduct proper inspection of structure. (DWR UCIP - omagana)

View of WS--dense vegetation along WS slope.

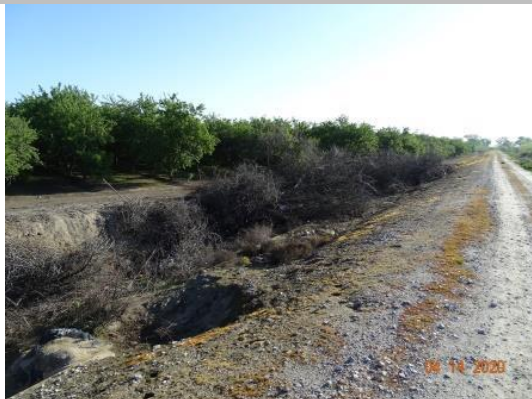
Photo 1 of 2 : SP_2020_NA0011_142_36_20200417_00037.jpg

LM Start	0.04	Rating **	M	Issue No.	36
LM End	0.06	Issue Type +	En	Location *	LS
Category	Earthen Levee			GPS Latitude/Longitude	
				Start	End
Item	Encroachments			37.046589 °	37.046722 °
				-120.427298 °	-120.426940 °
DWR ID	DWR_NA0011_01_s_2012_36				
Comment Code					
PR : Prunings					
Inspector Comment					
Remove the prunings from the landside slope.

Looking upstream at prunings left on the landside slope and toe. (Spring 2020)

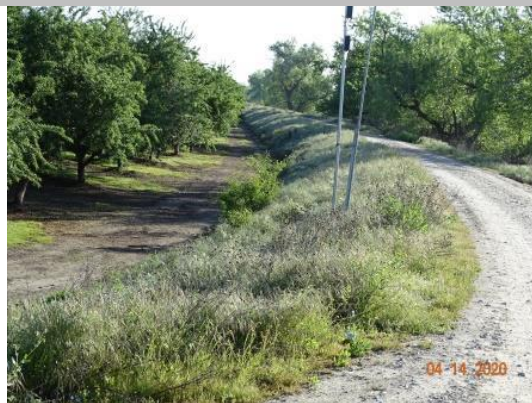
Photo 1 of 1 : SP_2020_NA0011_142_12_20200417_00038.jpg

LM Start	0.25	Rating **	U	Issue No.	12
LM End	0.80	Issue Type +	Ma	Location *	LS
Category	Earthen Levee			GPS Latitude/Longitude	
				Start	End
Item	Vegetation			37.047546 °	37.053543 °
				-120.423707 °	-120.417370 °
DWR ID	DWR_NA0011_01_s_2020_12				
Comment Code					
V1 : Control annual grass and weeds on the levee slopes and easements.					
Inspector Comment

View of the landside slope looking upstream. (Spring 2020)

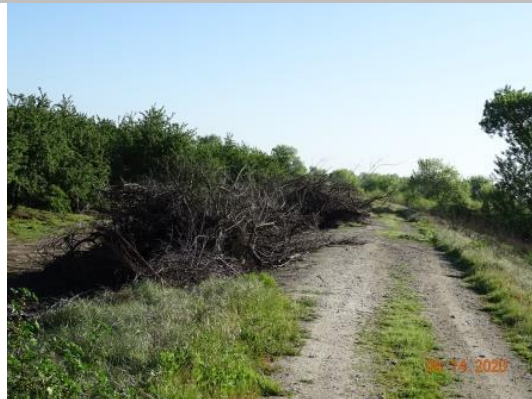
Photo 1 of 2 : SP_2020_NA0011_142_13_20200417_00040.jpg

LM Start	0.59	Rating **	U	Issue No.	13
LM End	0.61	Issue Type +	En	Location *	LS
Category	Earthen Levee			GPS Latitude/Longitude	
				Start	End
Item	Encroachments			37.050920 °	37.051093 °
				-120.419210 °	-120.418992 °
DWR ID	DWR_NA0011_01_f_2017_13				
Comment Code					
PR : Prunings					
Inspector Comment					
Remove the large pruning piles on landside slope. Pile obstructing levee crown access.

Large pruning piles obstructing the landside slope and toe. (Spring 2020)

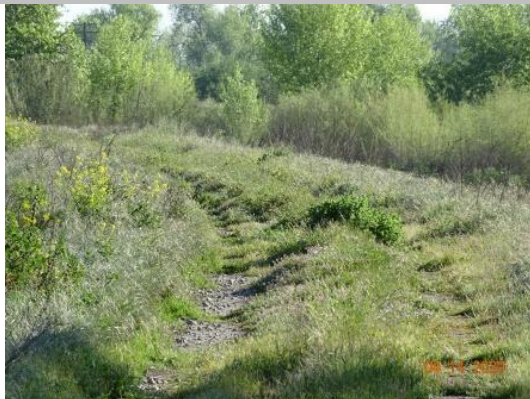
Photo 1 of 1 : SP_2020_NA0011_142_30_20200417_00042.jpg

LM Start	0.61	Rating **	U	Issue No.	30
LM End	0.80	Issue Type +	Ma	Location *	CR
Category	Earthen Levee			GPS Latitude/Longitude	
				Start	End
Item	Vegetation			37.051082 °	37.053543 °
				-120.419031 °	-120.417370 °
DWR ID	DWR_NA0011_01_s_2020_30				
Comment Code					
V9 : Keep the crown roadway free of vegetation.					
Inspector Comment

View of vegetation along the levee crown. (Spring 2020)

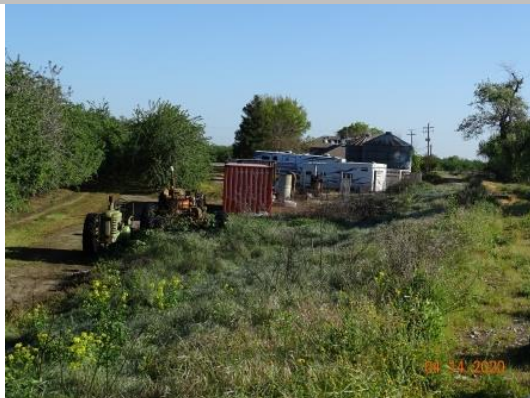
Photo 1 of 1 : SP_2020_NA0011_142_14_20200417_00045.jpg

LM Start	0.74	Rating **	U	Issue No.	14
LM End	0.78	Issue Type +	En	Location *	LS
Category	Earthen Levee			GPS Latitude/Longitude	
				Start	End
Item	Encroachments			37.052619 °	37.053238 °
				-120.417726 °	-120.417488 °
DWR ID	DWR_NA0011_01_s_2013_14				
Comment Code					
EQ : Equipment					
Inspector Comment					
Move equipment and debris away from levee to allow inspection and access to landside slope, toe and 10-foot easement.

Farm equipment and debris placed within the easement landside levee toe. (Spring 2020)

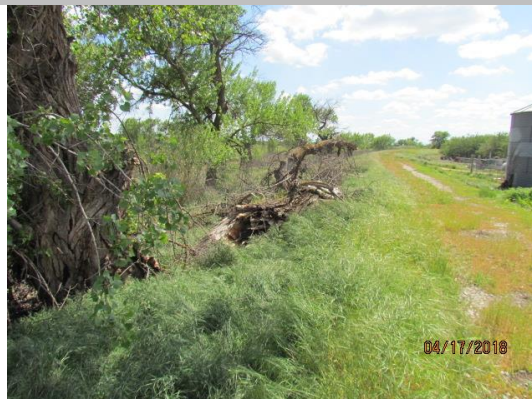
Photo 1 of 1 : SP_2020_NA0011_142_21_20200225_00012.jpg

LM Start	0.75	Rating **	U	Issue No.	21
LM End	0.75	Issue Type +	Ma	Location *	WS
Category	Earthen Levee			GPS Latitude/Longitude	
				Start	End
Item	Encroachments			37.052796 °	37.052796 °
				-120.417641 °	-120.417640 °
DWR ID	DWR_NA0011_01_f _ 2017_21				
Comment Code					
TR : Tree or limb					
Inspector Comment					
Remove tree limbs from waterside slope.

Looking west at tree limbs and branches on waterward slope. (Spring 2018)

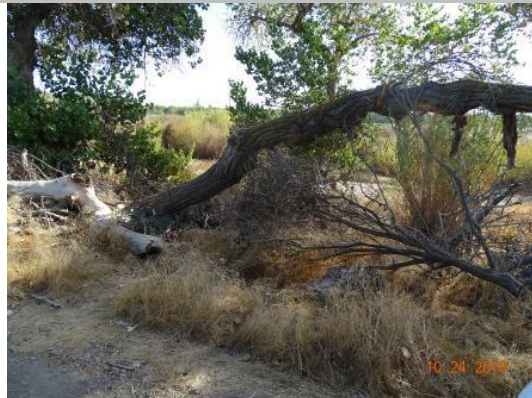
Photo 1 of 1 : SP_2020_NA0011_142_25_20200225_00015.jpg

LM Start	0.79	Rating **	U	Issue No.	25
LM End	0.79	Issue Type +	Ma	Location *	WS
Category	Earthen Levee			GPS Latitude/Longitude	
				Start	End
Item	Encroachments			37.053329 °	37.053329 °
				-120.417448 °	-120.417448 °
DWR ID	DWR_NA0011_01_f_2018_25				
Comment Code					
TR : Tree or limb					
Inspector Comment					
There is a fallen tree blocking the waterside slope.

tree limbs and trunks on waterside shoulder and slope. (Fall 2018)

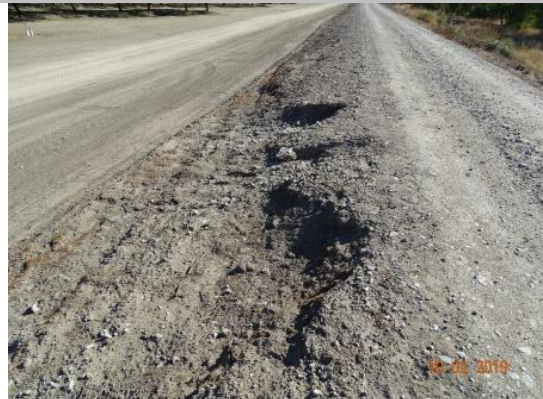
Photo 1 of 1 : SP_2020_NA0011_142_29_20200225_00017.jpg

View of erosion looking upstream along the landside slope. (Fall 2019)

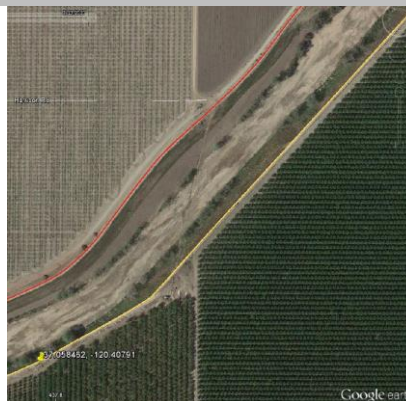
Photo 1 of 3 : UCIP_SP_2020_53155_75206.jpg

DS_ID:25456
FS_ID:53155
EP_NO: N/A
Repair Type: Non-Urgent
Crossing Status: Found
UCIP Comments: 10/31/2018 Pipe has been capped off. No integrity issues were observed during the site inspection. Crossing has been downgraded from Urgent to Non-Urgent. Need to coordinate with the CVFPB to determine if the unauthorized crossing will need to be removed, pending issue that needs to be resolved. (O. Magana - DWR UCIP)
07/14/2016 Open pipe still remains on WS through short levee. Need to contact owner to determine extent of work completed through section of levee. (DWR UCIP - omagana)
06/14/2016 Levee disturbed without prior authorization, it appears that the pipe owner did not notify CVFPB of the construction activity. Crossing was added to UCIP database. Spoke to Herman Phillips (DWR Levee Inspector) regarding unauthorized pipe installation along LS toe of U2. The LS toe of U2 (approximately 731 feet) was disturbed. DWR Inspector mentioned that Dario Dominguez with Madera County Flood Control, LMA representative, has sent the pipe owner notification of unauthorized excavation to replace existing pipe along U2 LS toe, dated May 5, 2016. After reviewing the timed aerial photographs (aerials) under Google Earth a new discovery was made regarding the extend of the area disturbed. Based on the aerials it appears that the new pipe system goes through U1 and U2 levees, across Ash Slough, and along LS toe of U2. The pipe through the levees and channel appears to tie into the work currently being done on the LS toe of U2. Both U1 and U2 levees appear to have been disturbed during 2014-2015. The aerials show that the crossing was not present in the aerial dated 4/5/2014, crossing was not present during the 2014 UCIP Inspection dated 5/6/2014, and the crossing was present in the aerial dated 3/18/2015. According to DWR Inspector, Dario Dominguez with Madera County Flood Control was notified of the additional unauthorized encroachment issue (unauthorized work completed in 2014-2015 on both levees and the channel) that could be related to the trench work being completed by Mr. Sterling. (DWR UCIP - omagana)

FIELD_STRUCT_DESC: *ILLEGAL ENCROACHMENT* 10-inch to 12-inch irrigation siphon pipe of an unknown material through both levees and across the channel, at an unknown depth. The pipe starts on the landside (LS) toe of Unit 1 (U1) and continues across the channel and through the Unit 2 (U2) levee. The pipe then runs along the LS toe of U2 for approximately 731 feet. This crossing was field discovered. The owner of this crossing is Michael Alexander Sterling, 19140 Faralton Road, Madera, CA 93638-0313.
FS Date: 10/31/2018 11:26:00 AM

Aerial photo of Encroachment visible through levee and channel in 2015.
(Source: Google Earth, 3/18/2015)

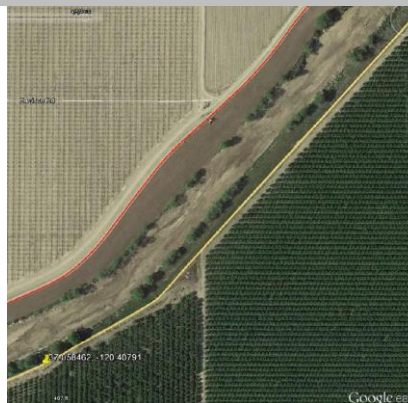
Photo 3 of 3 : UCIP_SP_2020_53155_75207.jpg

Aerial photo of Encroachment not present in 2014. (Source: Google Earth, 4/5/2014)

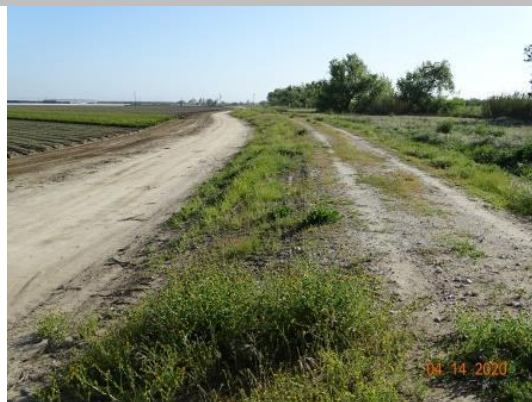
Photo 1 of 1 : SP_2020_NA0011_142_34_20200417_00044.jpg

LM Start	1.73	Rating **	M	Issue No.	34
LM End	2.35	Issue Type +	Ma	Location *	LS
Category	Earthen Levee			GPS Latitude/Longitude	
				Start	End
Item	Vegetation			37.061636 °	37.068545 °
				-120.405210 °	-120.398665 °
DWR ID	DWR_NA0011_01_s_2020_34				
Comment Code					
V1 : Control annual grass and weeds on the levee slopes and easements.					
Inspector Comment

View of landside slope looking upstream. (Spring 2020)

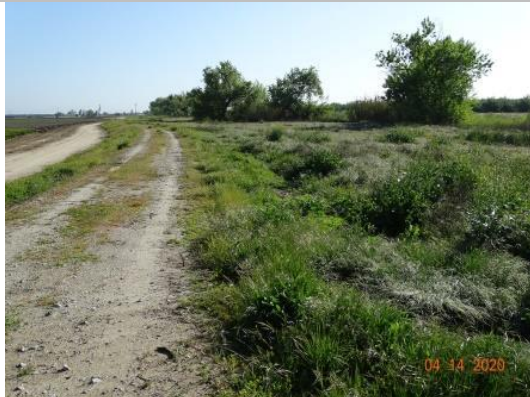
Photo 1 of 1 : SP_2020_NA0011_142_35_20200417_00046.jpg

LM Start	1.73	Rating **	U	Issue No.	35
LM End	2.35	Issue Type +	Ma	Location *	WS
Category	Earthen Levee			GPS Latitude/Longitude	
				Start	End
Item	Vegetation			37.061636 °	37.068564 °
				-120.405209 °	-120.398652 °
DWR ID	DWR_NA0011_01_s _ 2020_35				
Comment Code					
V1 : Control annual grass and weeds on the levee slopes and easements.					
Inspector Comment

View of vegetation growing along the waterside slope looking upstream.
(Spring 2020)

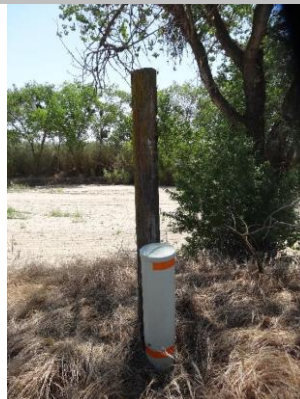
Photo 1 of 1 : UCIP_SP_2020_52846_71806.jpg

LM Start	2.09	Rating **	M	Issue No.	47
LM End	2.09	Issue Type +	En	Location *	
Category	Supplemental			GPS Latitude/Longitude	
				Start	End
Item	DWR UCIP Field Study			37.065569 °	37.065569 °
				-120.400752 °	-120.400752 °
DWR ID	21511				
Comment Code					
Inspector Comment					
DS_ID:21511 FS_ID:52846 EP_NO: N/A Repair Type: Non-Urgent Crossing Status: Indicator Found UCIP Comments: 05/06/2014 Need to contact to owner to get contact information. (DWR UCIP - O. Magana) FIELD_STRUCT_DESC: Telephone conduit of an unknown size or material through the levee, at an unknown depth. [Additional Reference(s): DWR Levee Log, 2005]. FS Date: 5/6/2014

Conduit box located on waterward side.

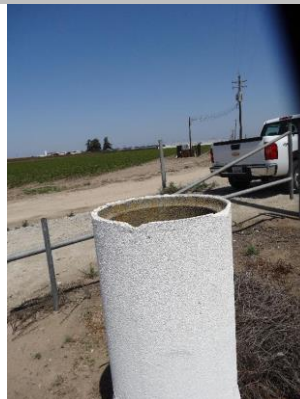
Photo 2 of 3 : UCIP_SP_2020_52847_71803.jpg

LM Start	2.10	Rating **	M	Issue No.	48
LM End	2.10	Issue Type +	En	Location *	
Category	Supplemental			GPS Latitude/Longitude	
				Start	End
Item	DWR UCIP Field Study			37.065649 °	37.065649 °
				-120.400663 °	-120.400663 °
DWR ID	25042				
Comment Code					
Inspector Comment					
DS_ID:25042 FS_ID:52847 EP_NO: N/A Repair Type: Non-Urgent Crossing Status: Found UCIP Comments: 05/06/2014 Need to contact owner to determine if crossing goes through levee. (DWR UCIP - O. Magana) FIELD_STRUCT_DESC: 10-inch or 12-inch drainage discharge pipe of an unknown material through the levee, at an unknown depth. Crossing visible inside a concrete standpipe on the waterside (WS). Potential pump station on the landside (LS), approximately 100 feet from the standpipe. This crossing was field discovered. FS Date: 5/6/2014

Standpipe visible on waterward side.

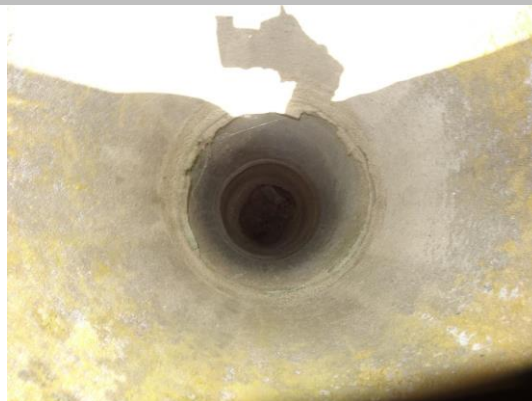
Photo 3 of 3 : UCIP_SP_2020_52847_71804.jpg

Inside view of concrete standpipe.

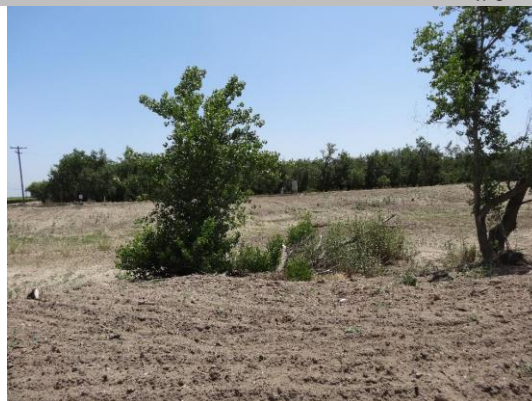
Photo 1 of 3 : UCIP_SP_2020_52848_69679.jpg

Comment Code						
Inspector Comment						
DS_ID:21512						
FS_ID:52848						
EP_NO: N/A						
Repair Type: Non-Urgent						
Crossing Status: Found						
UCIP Comments: 05/06/2014 Unable to determine details of crossing and whether crossing has been abandoned. Need to find owner and determine the alignment of crossing to confirm if pipe is being extended from opposite levee. (DWR UCIP - O. Magana)						
FIELD_STRUCT_DESC: *ABANDONED* Service pole, pump, and two 36-inch standpipes on the landside (LS). Pump not found during 2014 inspection. Three standpipes found on the LS. [Additional Reference(s): DWR Levee Log, 2005].						
FS Date: 5/6/2014

View of waterward side.

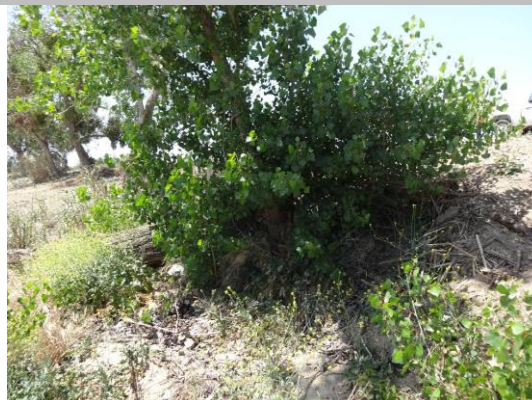
Photo 2 of 3 : UCIP_SP_2020_52848_69678.jpg

View of waterward slope--no signs of crossing visible.

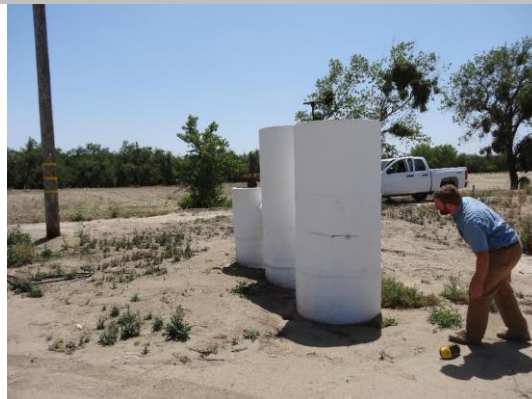
Photo 3 of 3 : UCIP_SP_2020_52848_69677.jpg

Three stand pipes visible on landward side.

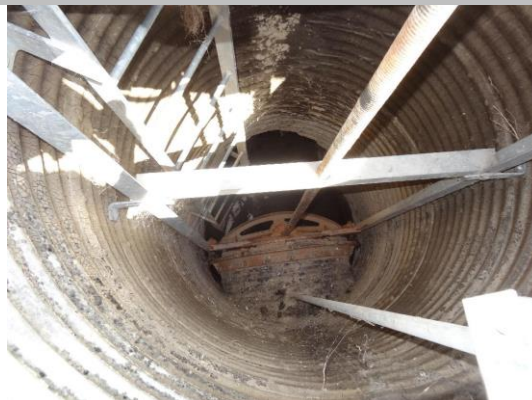
Photo 2 of 3 : UCIP_SP_2020_52830_71661.jpg

LM Start	0.01	Rating **	M	Issue No.	47	
LM End	0.01	Issue Type +	En	Location *		
Category	Supplemental			GPS Latitude/Longitude		
				Start		End
Item	DWR UCIP Field Study			37.045532 °	37.045532 °	
				-120.427268 °	-120.427268 °	
DWR ID	21585					
Comment Code						
Inspector Comment						
DS_ID:21585 FS_ID:52830 EP_NO: 8068 Repair Type: Non-Urgent Crossing Status: Found UCIP Comments: 05/06/2014 Unable to confirm if crossing found in the field corresponds to the crossing described under Permit 8068. Only 1 crossing found permit indicates 2 irrigation culverts. Need to contact owner to obtain additional details of crossing. (DWR UCIP - O. Magana) FIELD_STRUCT_DESC: To retain two irrigation culverts and siphons of an unknown size or material through the levee, at an unknown depth. Located at the intersection of Ash Slough and the Chowchilla Canal. FS Date: 5/6/2014

View of riser located on waterward side.

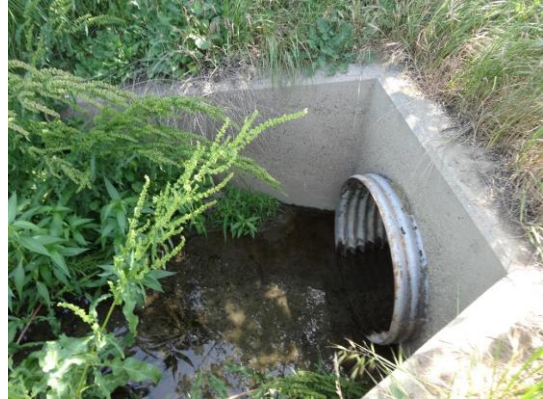
Photo 3 of 3 : UCIP_SP_2020_52830_71660.jpg

Pipe outlet on waterward side.

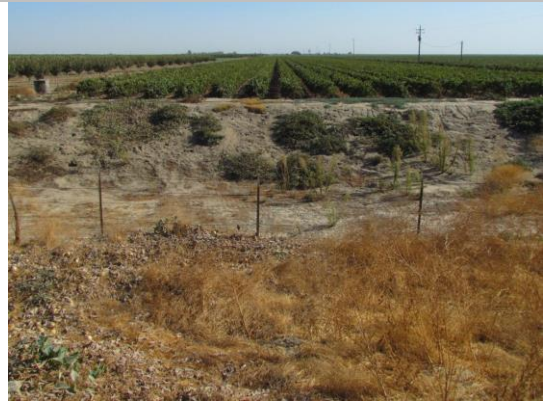
Photo 1 of 1 : SP_2020_NA0011_143_32_20200225_00025.jpg

LM Start	0.01	Rating **	U	Issue No.	32
LM End	0.03	Issue Type +	En	Location *	LS
Category	Earthen Levee			GPS Latitude/Longitude	
				Start	End
Item	Encroachments			37.045531 °	37.045620 °
				-120.427244 °	-120.426900 °
DWR ID	DWR_NA0011_02_f_2012_32				
Comment Code					
DT : Ditch					
Inspector Comment					
There is a settling basin on the landward side of the levee. This basin is very close to the landside easement.

Ash Slough at levee mile 0.01- 0.03. Settling basin on the landside levee berm.

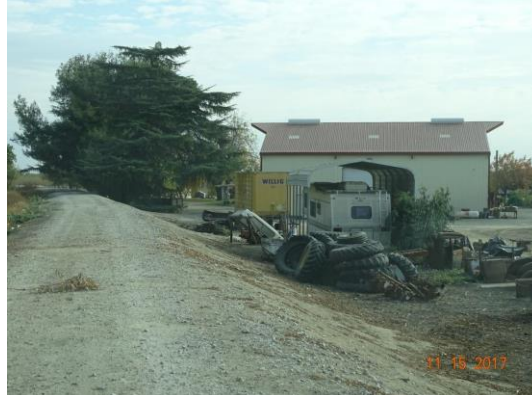
Photo 1 of 1 : SP_2020_NA0011_143_12_20200225_00009.jpg

LM Start	0.09	Rating **	U	Issue No.	12
LM End	0.16	Issue Type +	En	Location *	LS
Category	Earthen Levee			GPS Latitude/Longitude	
				Start	End
Item	Encroachments			37.045876 °	37.046198 °
				-120.425932 °	-120.424737 °
DWR ID	DWR_NA0011_02_f_2017_12				
Comment Code					
EQ : Equipment					
Inspector Comment

Move equipment away from levee slope, toe and 10-foot easement at toe to allow inspection and access.

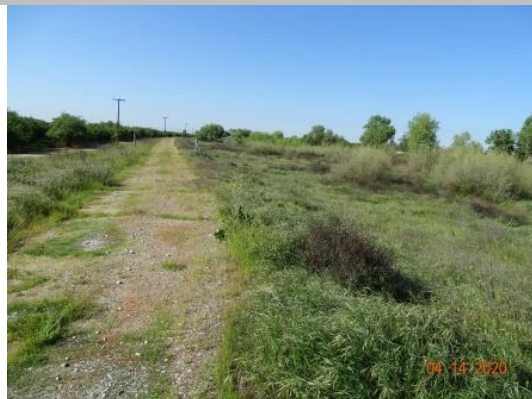
Photo 1 of 1 : SP_2020_NA0011_143_37_20200417_00050.jpg

LM Start	0.23	Rating **	U	Issue No.	37
LM End	0.94	Issue Type +	Ma	Location *	WS
Category	Earthen Levee			GPS Latitude/Longitude	
				Start	End
Item	Vegetation			37.046661 °	37.054490 °
				-120.423458 °	-120.415867 °
DWR ID	DWR_NA0011_02_s_2020_37				
Comment Code					
V1 : Control annual grass and weeds on the levee slopes and easements.					
Inspector Comment

View of the vegetation on the waterside slope looking downstream.
(Spring 2020)

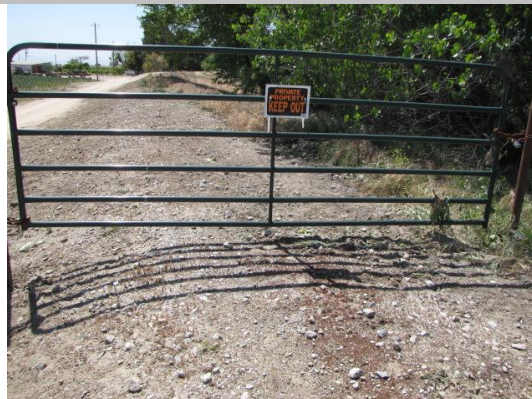
Photo 1 of 2 : SP_2020_NA0011_143_5_20200225_00004.jpg

This fence was not authorized by CVFPB. The District is aware of the fence. The landowner installed the fence and gate across the levee section because he has been broken into frequently and had many items stolen in the past. An inspector met with the landowner on 4-29-2014 and he let the inspector put a State lock on his gate to gain access to the levee.

Unauthorized gate and metal fence placed on slope and toe of levee section. Photo taken 4-17-2013.

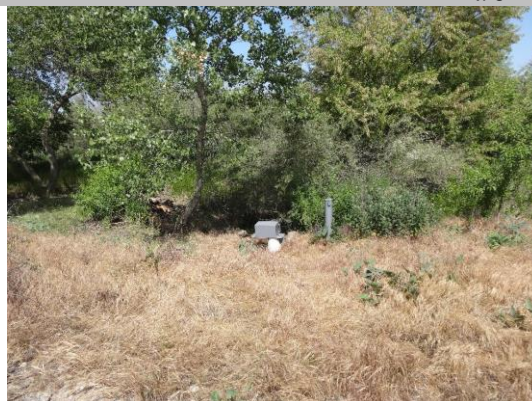
Photo 1 of 3 : UCIP_SP_2020_52834_64463.jpg

Comment Code						
Inspector Comment						
DS_ID:21514 FS_ID:52834 EP_NO: N/A Repair Type: Non-Urgent Crossing Status: Found UCIP Comments: 05/06/2014 Need to contact owner to determine details of crossing and permit information authorizing crossing. Dense vegetation limits the inspector's visibility to identify signs of pipe failure (leaks) along the slope. Recommend removing vegetation along pipe alignment to conduct proper inspection of structure and appurtenances. (DWR UCIP - O. Magana) FIELD_STRUCT_DESC: Gravity drainage pipe of an unknown size or material through the levee, at a skew and at an unknown depth. Concrete discharge structure at the waterside (WS) end. Standpipe with gage house off the landside (LS) toe. No gage house found on the LS during inspection. [Additional Reference(s): DWR Levee Log, 2005]. FS Date: 5/6/2014

View of waterward side.

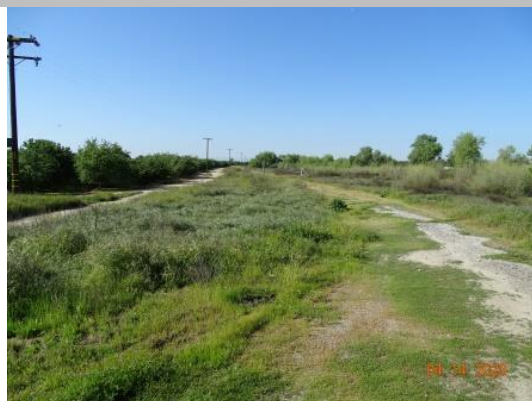
Photo 1 of 1 : SP_2020_NA0011_143_38_20200417_00051.jpg

LM Start	0.32	Rating **	U	Issue No.	38
LM End	0.94	Issue Type +	Ma	Location *	LS
Category	Earthen Levee			GPS Latitude/Longitude	
				Start	End
Item	Vegetation			37.047264 °	37.054490 °
				-120.422125 °	-120.415867 °
DWR ID	DWR_NA0011_02_s_2020_38				
Comment Code					
V1 : Control annual grass and weeds on the levee slopes and easements.					
Inspector Comment

Looking downstream along the landside slope. (Spring 2020)

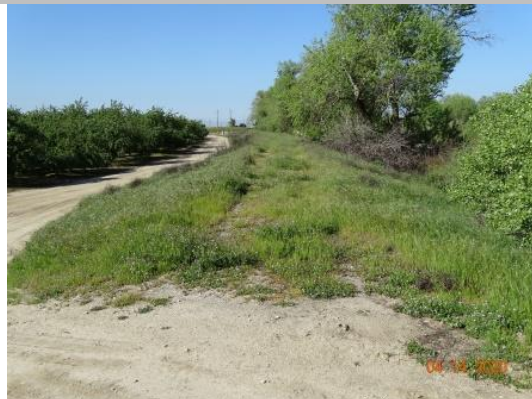
Photo 1 of 1 : SP_2020_NA0011_143_42_20200417_00052.jpg

LM Start	0.32	Rating **	U	Issue No.	42
LM End	0.44	Issue Type +	Ma	Location *	CR
Category	Earthen Levee			GPS Latitude/Longitude	
				Start	End
Item	Vegetation			37.047265 °	37.048561 °
				-120.422125 °	-120.420562 °
DWR ID	DWR_NA0011_02_s_2020_42				
Comment Code					
V9 : Keep the crown roadway free of vegetation.					
Inspector Comment

View of levee crown looking downstream. (Spring 2020)

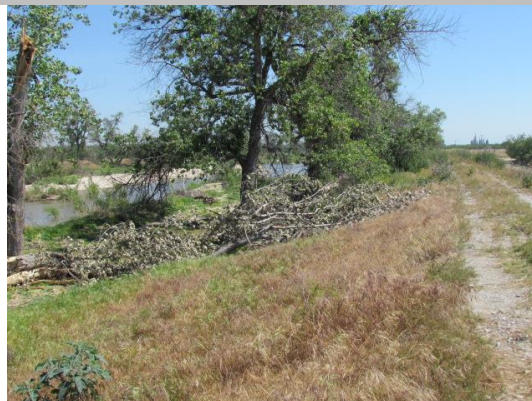
Photo 1 of 1 : SP_2020_NA0011_143_33_20200225_00026.jpg

LM Start	0.33	Rating **	U	Issue No.	33
LM End	0.42	Issue Type +	Ma	Location *	WS
Category	Earthen Levee			GPS Latitude/Longitude	
				Start	End
Item	Encroachments			37.047485 °	37.048403 °
				-120.422037 °	-120.420810 °
DWR ID	DWR_NA0011_02_s_2017_33				
Comment Code					
TR : Tree or limb					
Inspector Comment					
Remove the dead fallen trees from the waterside slope.

Dead fallen trees on the waterside levee slope and shoulder.

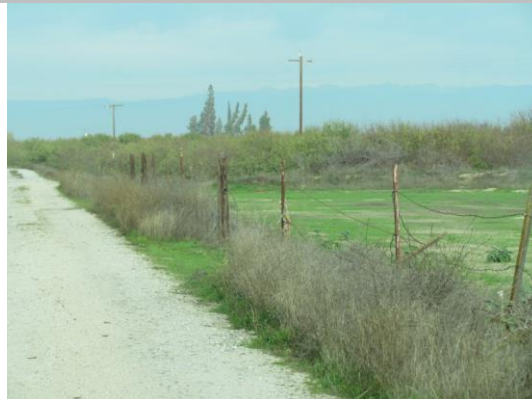
Photo 1 of 1 : SP_2020_NA0011_143_11_20200225_00008.jpg

LM Start	0.45	Rating **	M	Issue No.	11
LM End	0.53	Issue Type +	En	Location *	LS
Category	Earthen Levee			GPS Latitude/Longitude	
				Start	End
Item	Encroachments			37.048627 °	37.049342 °
				-120.420357 °	-120.419370 °
DWR ID	DWR_NA0011_02_s_2012_11				
Comment Code					
FE : Fence					
Inspector Comment					
Wire fence on the landside levee shoulder along with unwanted tall weed growth.

Fence on the landside slope.

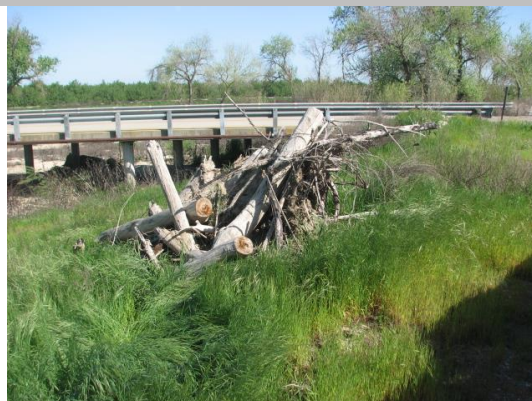
Photo 1 of 1 : SP_2020_NA0011_143_34_20200225_00027.jpg

LM Start	0.93	Rating **	M	Issue No.	34
LM End	0.93	Issue Type +	Ma	Location *	WS
Category	Earthen Levee			GPS Latitude/Longitude	
				Start	End
Item	Encroachments			37.054407 °	37.054407 °
				-120.415928 °	-120.415928 °
DWR ID	DWR_NA0011_02_s_2017_34				
Comment Code					
TR : Tree or limb					
Inspector Comment					
Remove the prunings from the waterside slope.

Looking downstream at bush pile on waterward slope. (Spring 2018)

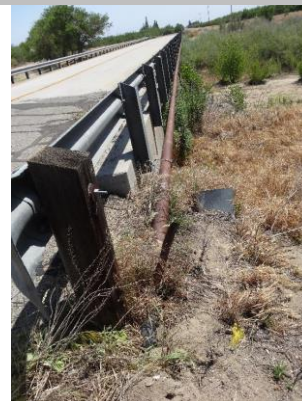
Photo 2 of 3 : UCIP_SP_2020_52839_71822.jpg

DS_ID:25043
FS_ID:52839
EP_NO: N/A
Repair Type: Non-Urgent
Crossing Status: Found
UCIP Comments: 05/06/2014 Need to contact owner to determine status. Need permit authorizing work. (DWR UCIP - O. Magana)
FIELD_STRUCT_DESC: 5-inch steel communications conduit along the downstream face of the bridge. The upstream face has a 2-inch pipe cut at the corner. This crossing was field discovered.
FS Date: 5/6/2014

View of steel conduit through levee and above channel.

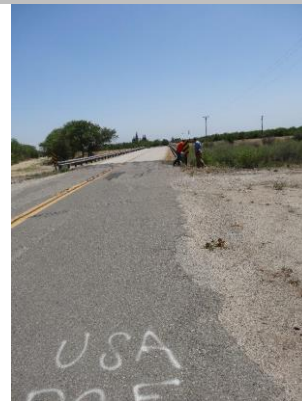
Photo 3 of 3 : UCIP_SP_2020_52839_71821.jpg

LM Start	0.94	Rating **	M	Issue No.	49 (cont)
LM End	0.94	Issue Type +	En	Location *	
Category	Supplemental		GPS Latitude/Longitude		
			Start	End	
Item	DWR UCIP Field Study		37.054547 °	37.054547 °	
			-120.415826 °	-120.415826 °	
DWR ID	25043

Overview of bridge.

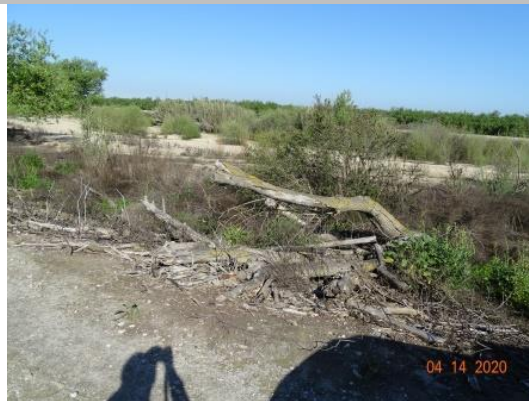
Photo 1 of 1 : SP_2020_NA0011_143_27_20200417_00053.jpg

LM Start	0.98	Rating **	U	Issue No.	27
LM End	1.52	Issue Type +	Ma	Location *	WS
Category	Earthen Levee			GPS Latitude/Longitude	
				Start	End
Item	Encroachments			37.054928 °	37.058752 °
				-120.415482 °	-120.407323 °
DWR ID	DWR_NA0011_02_s_2017_27				
Comment Code					
TR : Tree or limb					
Inspector Comment					
Remove the dead trees from the waterside slope and shoulder.

Branches left along the waterside slope from high flow. (Spring 2020)

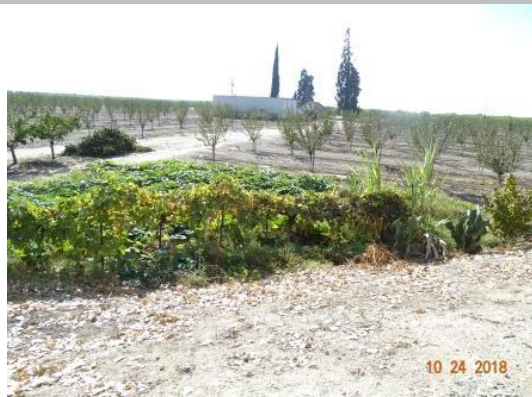
Photo 1 of 1 : SP_2020_NA0011_143_18_20200225_00012.jpg

LM Start	1.24	Rating **	M	Issue No.	18
LM End	1.24	Issue Type +	En	Location *	LS
Category	Earthen Levee			GPS Latitude/Longitude	
				Start	End
Item	Encroachments			37.056226 °	37.056226 °
				-120.411066 °	-120.411066 °
DWR ID	DWR_NA0011_02_f_2017_18				
Comment Code					
LI : Landscape Irrigation					
Inspector Comment					
Landowner removed most of the landscaping except for cactus and grapevines planted at landward toe.

Grapevines, landscaping vegetation, and cactus. (Fall 2018)

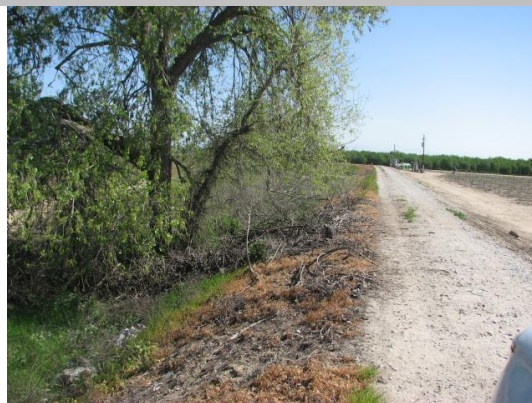
Photo 1 of 1 : SP_2020_NA0011_143_25_20200225_00019.jpg

LM Start	1.51	Rating **	M	Issue No.	25
LM End	1.52	Issue Type +	Ma	Location *	WS
Category	Earthen Levee			GPS Latitude/Longitude	
				Start	End
Item	Trim / Thin Trees			37.058652 °	37.058802 °
				-120.407638 °	-120.407350 °
DWR ID	DWR_NA0011_02_s_2012_25				
Comment Code					
T4 : Trim trees over roadway to at least 12 feet above ground level.					
Inspector Comment					
Trim the trees on the waterside slope levee miles 1.51-1.52.

Looking downstream at untrimmed tree on waterward slope. (Spring 2018)

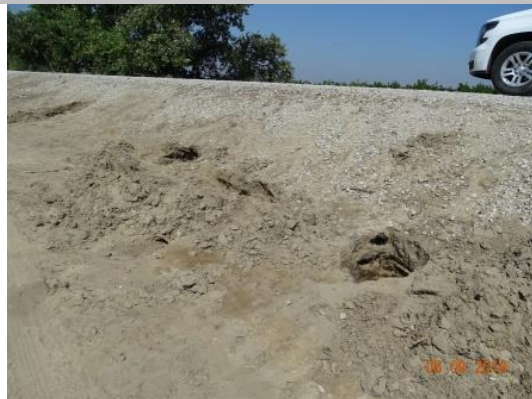
Photo 1 of 2 : SP_2020_NA0011_143_29_20200225_00023.jpg

LM Start	1.52	Rating **	U	Issue No.	29
LM End	1.62	Issue Type +	En	Location *	LS
Category	Earthen Levee			GPS Latitude/Longitude	
				Start	End
Item	Encroachments			37.059016 °	37.058978 °
				-120.406754 °	-120.406847 °
DWR ID	DWR_NA0011_02_f_2018_29				
Comment Code					
LI : Landscape Irrigation					
Inspector Comment					
Irrigation valves set into levee slope and toe.

Digging around valves recently occurred. Appears to be for maintenance of irrigation system. (Spring 2019)

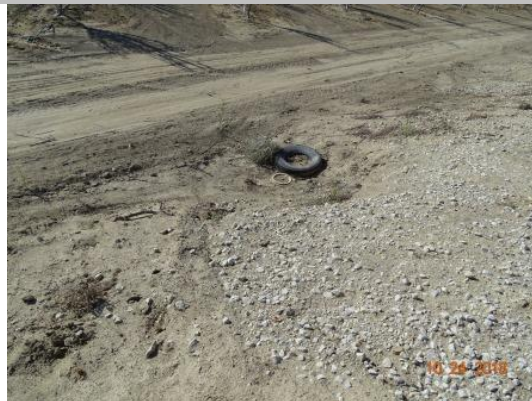
Photo 2 of 2 : SP_2020_NA0011_143_29_20200225_00024.jpg

LM Start	1.52	Rating **	U	Issue No.	29 (cont)
LM End	1.62	Issue Type +	En	Location *	LS

Representative view of irrigation valve. (Fall 2018)

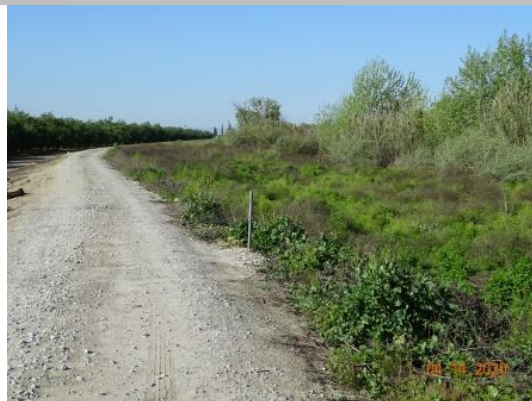
Photo 1 of 1 : SP_2020_NA0011_143_30_20200417_00054.jpg

LM Start	1.59	Rating **	U	Issue No.	30
LM End	2.03	Issue Type +	Ma	Location *	WS
Category	Earthen Levee			GPS Latitude/Longitude	
				Start	End
Item	Vegetation			37.059265 °	37.064046 °
				-120.406242 °	-120.401127 °
DWR ID	DWR_NA0011_02_s_2020_30				
Comment Code					
V1 : Control annual grass and weeds on the levee slopes and easements.					
Inspector Comment

Vegetation growing on the waterside slope. (Spring 2020)

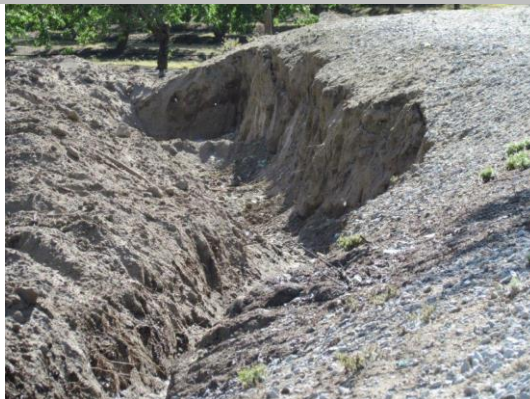
Photo 2 of 3 : UCIP_SP_2020_52842_75227.jpg

UCIP Comments: 7/14/2016 Repair in progress--According to LMA representative, Dario Dominguez, owner has repaired levee slope and compacted material per CVFPB's requirement (compaction tests have been performed). Need to confirm compaction tests were provided to DWR Inspector-Herman Phillips. (DWR UCIP - omagana)6/14/2016 Levee disturbed without prior authorization, it appears that the pipe owner did not notify CVFPB of the construction activity. Crossing was added to UCIP database. Spoke to Herman Phillips (DWR Levee Inspector) regarding unauthorized pipe installation along LS toe of U2. The LS toe of U2 (approximately 731 feet) was disturbed. DWR Inspector mentioned that Dario Dominguez with Madera County Flood Control, LMA representative, has sent the pipe owner notification of unauthorized excavation to replace existing pipe along U2 LS toe, dated May 5, 2016. After reviewing the timed aerial photographs (aerials) under Google Earth a new discovery was made regarding the extend of the area disturbed. Based on the aerials it appears that the new pipe system goes through U1 and U2 levees, across Ash Slough, and along LS toe of U2. The pipe through the levees and channel appears to tie into the work currently being done on the LS toe of U2. Both U1 and U2 levees appear to have been disturbed during 2014-2015. The aerials show that the crossing was not present in the aerial dated 4/5/2014, crossing was not present during the 2014 UCIP Inspection dated 5/6/2014, and the crossing was present in the aerial dated 3/18/2015. According to DWR Inspector, Dario Dominguez with Madera County Flood Control was notified of the additional unauthorized encroachment issue (unauthorized work completed in 2014-2015 on both levees and the channel) that could be related to the trench work being completed by Mr. Sterling. (DWR UCIP - omagana)

View of cut on LS slope of U2 at LM 1.49 (most downstream end of the open trench, photo 1 of 2).

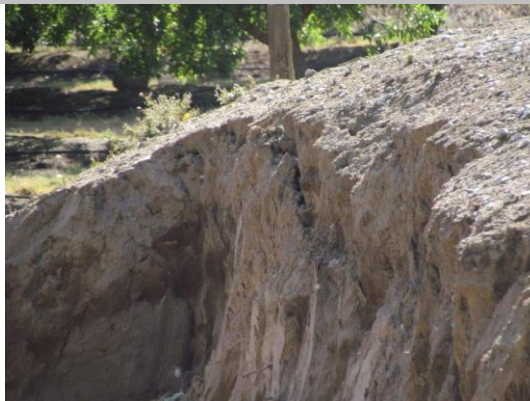
Photo 3 of 3 : UCIP_SP_2020_52842_75224.jpg

Close-up view of cut on LS slope at U2 LM 1.49 (the most downstream end of open trench, photo 2 of 2)

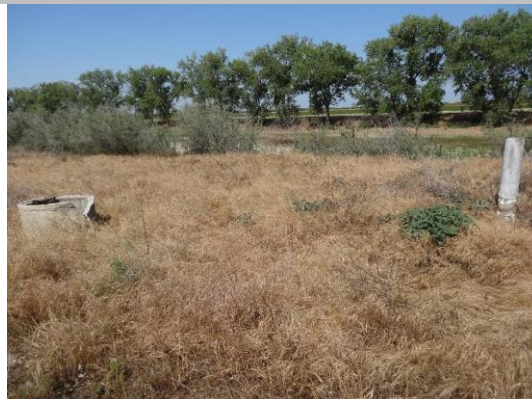
Photo 1 of 3 : UCIP_SP_2020_52844_71815.jpg

LM Start	2.02	Rating **	M	Issue No.	51	
LM End	2.02	Issue Type +	En	Location *		
Category	Supplemental			GPS Latitude/Longitude		
				Start	End	
Item	DWR UCIP Field Study			37.063982 °	37.063982 °	
				-120.401165 °	-120.401165 °	
DWR ID	25045					
Comment Code						
Inspector Comment						
DS_ID:25045 FS_ID:52844 EP_NO: N/A Repair Type: Non-Urgent Crossing Status: Indicator Found UCIP Comments: 05/06/2014 Need to contact owner to determine additional information about crossing and potential appurtenances. (DWR UCIP - O. Magana) FIELD_STRUCT_DESC: *ABANDONED* 36-inch pipe of an unknown material or purpose through the levee, at an unknown depth. The pipe is filled with concrete. This crossing was field discovered. FS Date: 5/6/2014

Standpipes visible on waterward side.

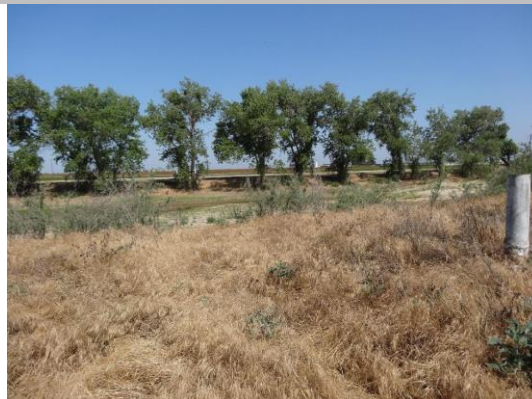
Photo 3 of 3 : UCIP_SP_2020_52844_71819.jpg

LM Start	2.02	Rating **	M	Issue No.	51 (cont)
LM End	2.02	Issue Type +	En	Location *	
Category	Supplemental		GPS Latitude/Longitude		
			Start	End	
Item	DWR UCIP Field Study		37.063982 °	37.063982 °	
			-120.401165 °	-120.401165 °	
DWR ID	25045

View of waterward side.

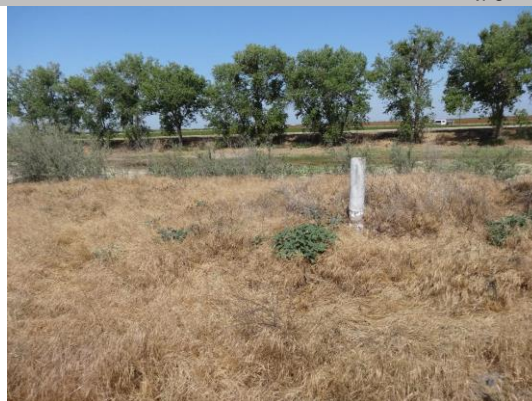
Photo 1 of 3 : UCIP_SP_2020_52845_71809.jpg

DS_ID:25044
 FS_ID:52845
 EP_NO: N/A
 Repair Type: Non-Urgent
 Crossing Status: Found
 UCIP Comments: 05/06/2014 Need to contact owner to determine status. (DWR UCIP - O. Magana)
 FIELD_STRUCT_DESC: 10-inch pipes located on waterside (WS). Unsure if these pipes go through the levee. These pipes were field discovered.
 FS Date: 5/6/2014

Tall concrete standpipe visible on waterward side.

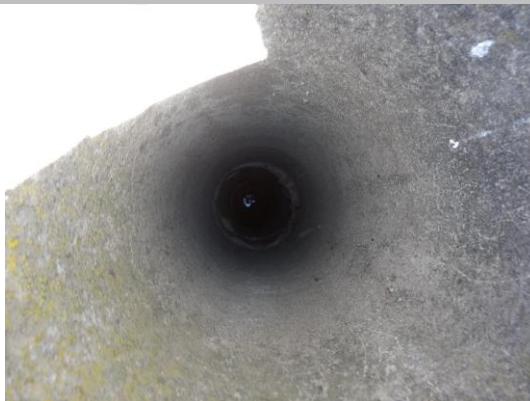
Photo 3 of 3 : UCIP_SP_2020_52845_71807.jpg

Inside view of 10-inch concrete standpipe.

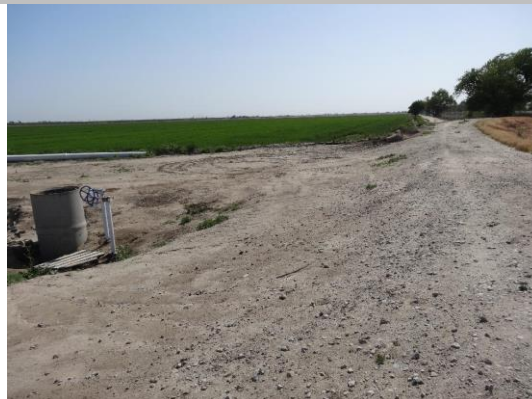
Photo 1 of 3 : UCIP_SP_2020_52829_64476.jpg

LM Start	0.00	Rating **	M	Issue No.	36	
LM End	0.00	Issue Type +	En	Location *		
Category	Supplemental			GPS Latitude/Longitude		
				Start		End
Item	DWR UCIP Field Study			36.996593 °		36.996593 °
				-120.373636 °		-120.373636 °
DWR ID	21516					
Comment Code						
Inspector Comment						
DS_ID:21516 FS_ID:52829 EP_NO: N/A Repair Type: Non-Urgent Crossing Status: Found UCIP Comments: 05/06/2014 Unable to confirm if crossing is still being used. Need to contact owner to determine status of crossing. (DWR UCIP - O. Magana) FIELD_STRUCT_DESC: 18-inch steel irrigation discharge pipe through the levee, at an unknown depth. Slant pump on the waterside (WS) slope. The levee log indicates that the abandonment of the Chowchilla Canal Siphon was backfilled through the levee section. [Additional Reference(s): DWR Levee Log, 2005]. FS Date: 5/6/2014

View of landward side.

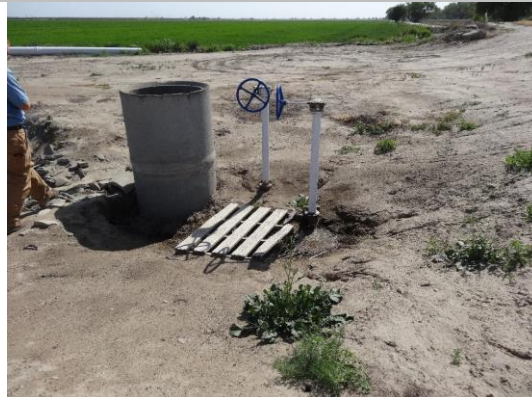
Photo 2 of 3 : UCIP_SP_2020_52829_64475.jpg

Close up of concrete standpipe and multiple positive closure devices.

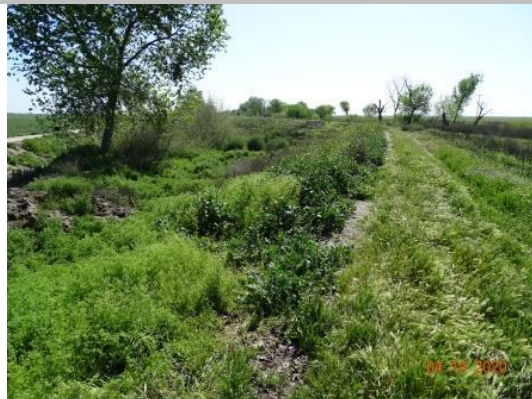
Photo 1 of 1 : SP_2020_NA0011_144_9_20200417_00028.jpg

LM Start	0.04	Rating **	U	Issue No.	9
LM End	1.51	Issue Type +	Ma	Location *	LS
Category	Earthen Levee			GPS Latitude/Longitude	
				Start	End
Item	Vegetation			36.996543 °	36.996607 °
				-120.373043 °	-120.346570 °
DWR ID	DWR_NA0011_03_f_2019_9				
Comment Code					
V1 : Control annual grass and weeds on the levee slopes and easements.					
Inspector Comment

Looking upstream at vegetation along the landside slope. (Spring 2020)

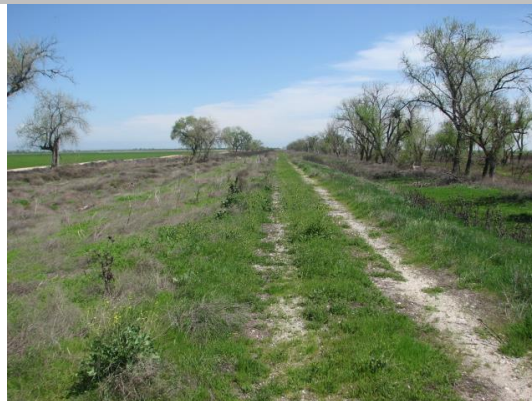
Photo 1 of 1 : SP_2020_NA0011_144_32_20200225_00020.jpg

LM Start	0.08	Rating **	M	Issue No.	32
LM End	1.51	Issue Type +	Ma	Location *	CR
Category	Earthen Levee			GPS Latitude/Longitude	
				Start	End
Item	Crown Surface / Depressions / Rutting			36.996264 °	36.996613 °
				-120.372350 °	-120.346570 °
DWR ID	DWR_NA0011_03_s_2014_32				
Comment Code					
C3 : Add appropriate gravel or road base. Grade and compact.					
Inspector Comment					
Regrade the crown for proper drainage and add more rock to crown.

Looking downstream at levee crown. (Spring 2018)

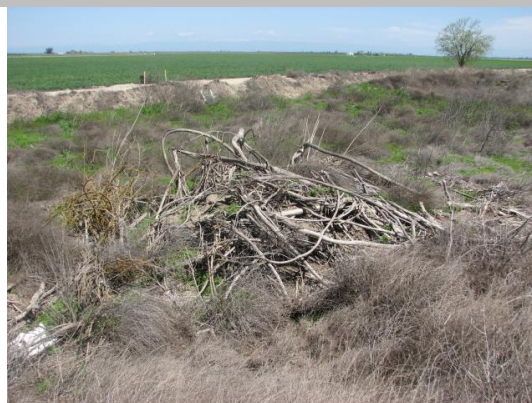
Photo 1 of 1 : SP_2020_NA0011_144_20_20200225_00019.jpg

LM Start	0.08	Rating **	U	Issue No.	20
LM End	0.08	Issue Type +	Ma	Location *	LS
Category	Earthen Levee			GPS Latitude/Longitude	
				Start	End
Item	Encroachments			36.996204 °	36.996201 °
				-120.372352 °	-120.372345 °
DWR ID	DWR_NA0011_03_s_2012_20				
Comment Code					
PR : Prunings					
Inspector Comment					
Remove the prunings from the landside slope.

Looking at prunings on landward slope. (Spring 2018)

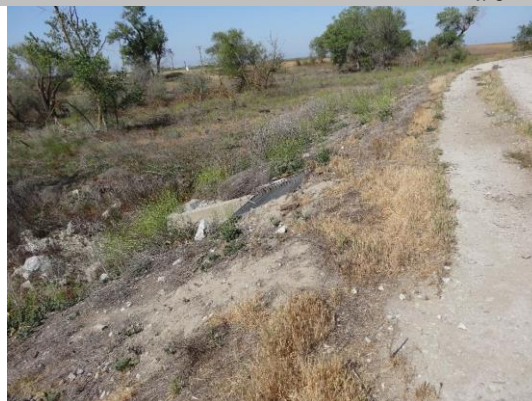
Photo 1 of 3 : UCIP_SP_2020_52832_69689.jpg

LM Start	0.10	Rating **	M	Issue No.	37	
LM End	0.10	Issue Type +	En	Location *		
Category	Supplemental			GPS Latitude/Longitude		
				Start		End
Item	DWR UCIP Field Study			36.996177 °		36.996177 °
				-120.371967 °		-120.371967 °
DWR ID	21517					
Comment Code						
Inspector Comment						
DS_ID:21517 FS_ID:52832 EP_NO: N/A Repair Type: Non-Urgent Crossing Status: Found UCIP Comments: 05/06/2014 Need to contact owner to determine status of crossing. Unable to determine if crossing is in use. (DWR UCIP - O. Magana) FIELD_STRUCT_DESC: 36-inch corrugated metal gravity drainage pipe through the levee, 7.3 feet below the crown. Headwall and wing wall on each end. Flap gate on the waterside (WS) end. [Additional Reference(s): DWR Levee Log, 2005]. FS Date: 5/6/2014

View of waterward side.

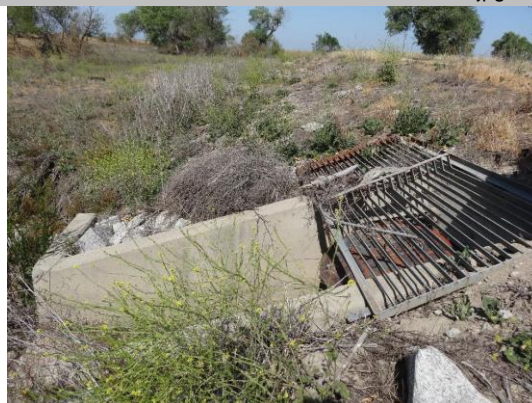
Photo 2 of 3 : UCIP_SP_2020_52832_69687.jpg

Debris screen visible on waterward headwall.

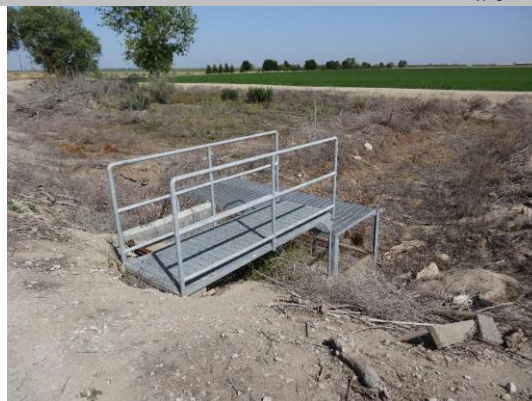
Photo 3 of 3 : UCIP_SP_2020_52832_69688.jpg

View of landward side.

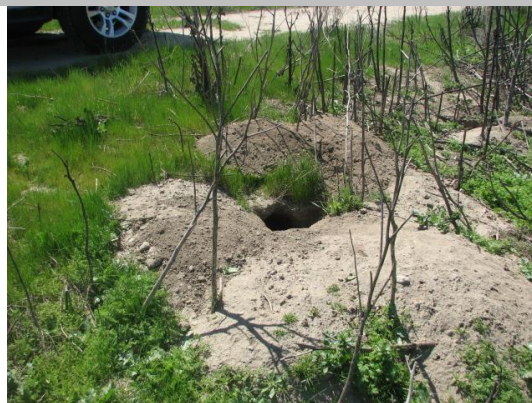
Photo 1 of 1 : SP_2020_NA0011_144_6_20200225_00004.jpg

LM Start	0.40	Rating **	U	Issue No.	6
LM End	1.51	Issue Type +	Ma	Location *	LS
Category	Earthen Levee		GPS Latitude/Longitude		
			Start	End	
Item	Animal Control		36.996208 °	36.996607 °	
			-120.366550 °	-120.346568 °	
DWR ID	DWR_NA0011_03_f_2016_6

Looking at rodent hole on landward slope. (Spring 2018)

LMA should install rodent bait stations placed along the landside slope and/or shoulder at from LM 0.40 to LM 1.51. Unable to see the levee slopes during Spring 2019 inspection however did observe rodents running across the roadway.

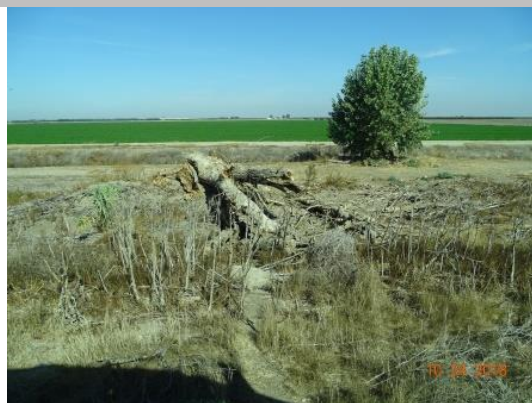
Photo 1 of 1 : SP_2020_NA0011_144_10_20200225_00012.jpg

LM Start	0.45	Rating **	U	Issue No.	10
LM End	0.45	Issue Type +	Ma	Location *	LS
Category	Earthen Levee		GPS Latitude/Longitude		
			Start	End	
Item	Encroachments		36.996224 °	36.996224 °	
			-120.365692 °	-120.365692 °	
DWR ID	DWR_NA0011_03_f_2018_10

View of dead tree on the landside slope. (Fall 2018)

Remove the dead tree from the landside slope.

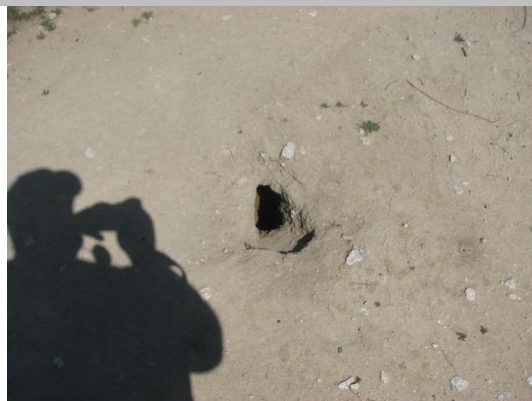
Photo 1 of 1 : SP_2020_NA0011_144_5_20200225_00003.jpg

LM Start	0.46	Rating **	U	Issue No.	5
LM End	0.46	Issue Type +	Ma	Location *	CR
Category	Earthen Levee			GPS Latitude/Longitude	
				Start	End
Item	Animal Control			36.996238 °	36.996238 °
				-120.365563 °	-120.365563 °
DWR ID	DWR_NA0011_03_s_2018_5				
Comment Code					
A3 : No rodents visible, but rodent burrows visible; need to backfill and compact or grout burrows.					
Inspector Comment					
There is a large rodent hole on the crown of the levee.

Looking at rodent hole on levee crown. (Spring 2018)

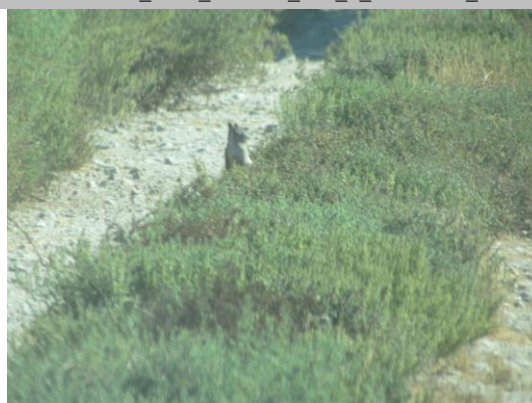
Photo 1 of 1 : SP_2020_NA0011_144_8_20200225_00010.jpg

LM Start	0.71	Rating **	M	Issue No.	8
LM End	1.51	Issue Type +	Ma	Location *	CR
Category	Earthen Levee			GPS Latitude/Longitude	
				Start	End
Item	Animal Control			36.996257 °	36.996607 °
				-120.361025 °	-120.346568 °
DWR ID	DWR_NA0011_03_f_2016_8				
Comment Code					
A1 : Exterminate rodents and backfill and compact or grout burrows.					
Inspector Comment					
Exterminate rodents from the roadway. Active rodents observed during inspection at this site.

Berenda Slough Unit 3 looking upstream from levee miles 0.71 - to 1.51.

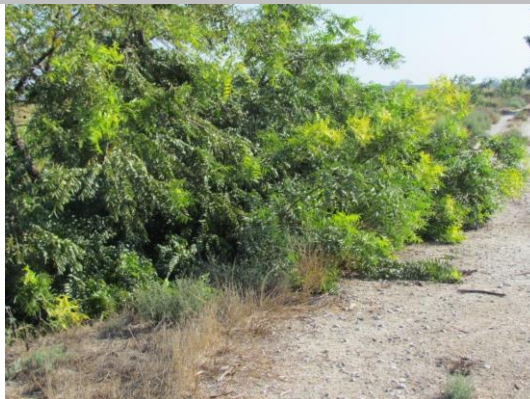
Photo 1 of 1 : SP_2020_NA0011_144_11_20200225_00013.jpg

LM Start	1.04	Rating **	U	Issue No.	11
LM End	1.05	Issue Type +	Ma	Location *	LS
Category	Earthen Levee			GPS Latitude/Longitude	
				Start	End
Item	Trim / Thin Trees			36.996613 °	36.996610 °
				-120.355055 °	-120.354995 °
DWR ID	DWR_NA0011_03_s_2012_11				
Comment Code					
T1 : Trim trees to at least five feet above ground level.					
Inspector Comment					
Remove nut tree from the slope.

Walnut trees blocking the view of the landside levee section.

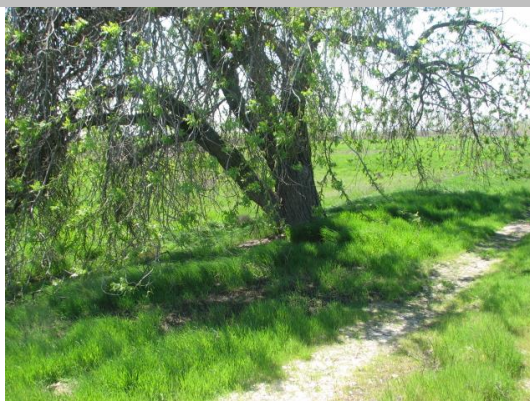
Photo 1 of 1 : SP_2020_NA0011_144_14_20200225_00014.jpg

LM Start	1.09	Rating **	U	Issue No.	14
LM End	1.09	Issue Type +	Ma	Location *	WS
Category	Earthen Levee			GPS Latitude/Longitude	
				Start	End
Item	Trim / Thin Trees			36.996618 °	36.996618 °
				-120.354307 °	-120.354307 °
DWR ID	DWR_NA0011_03_s_2017_14				
Comment Code					
T2 : Thin trees to allow visibility of the ground and room to flood fight.					
Inspector Comment					
Branches hanging over crown are beginning to obstruct access.

Looking at untrimmed tree on waterward shoulder. (Spring 2018)
